RC-East, Eastern Afghanistan, GA-ADT, Wardak Province, Chak E Dam, Sluice Canal  
Sediment Analysis  
Henry F. Shovic, PhD  
Mar 17, 2012

Completed under CERP contract 20111011143900 for GA-ADT, RC-East

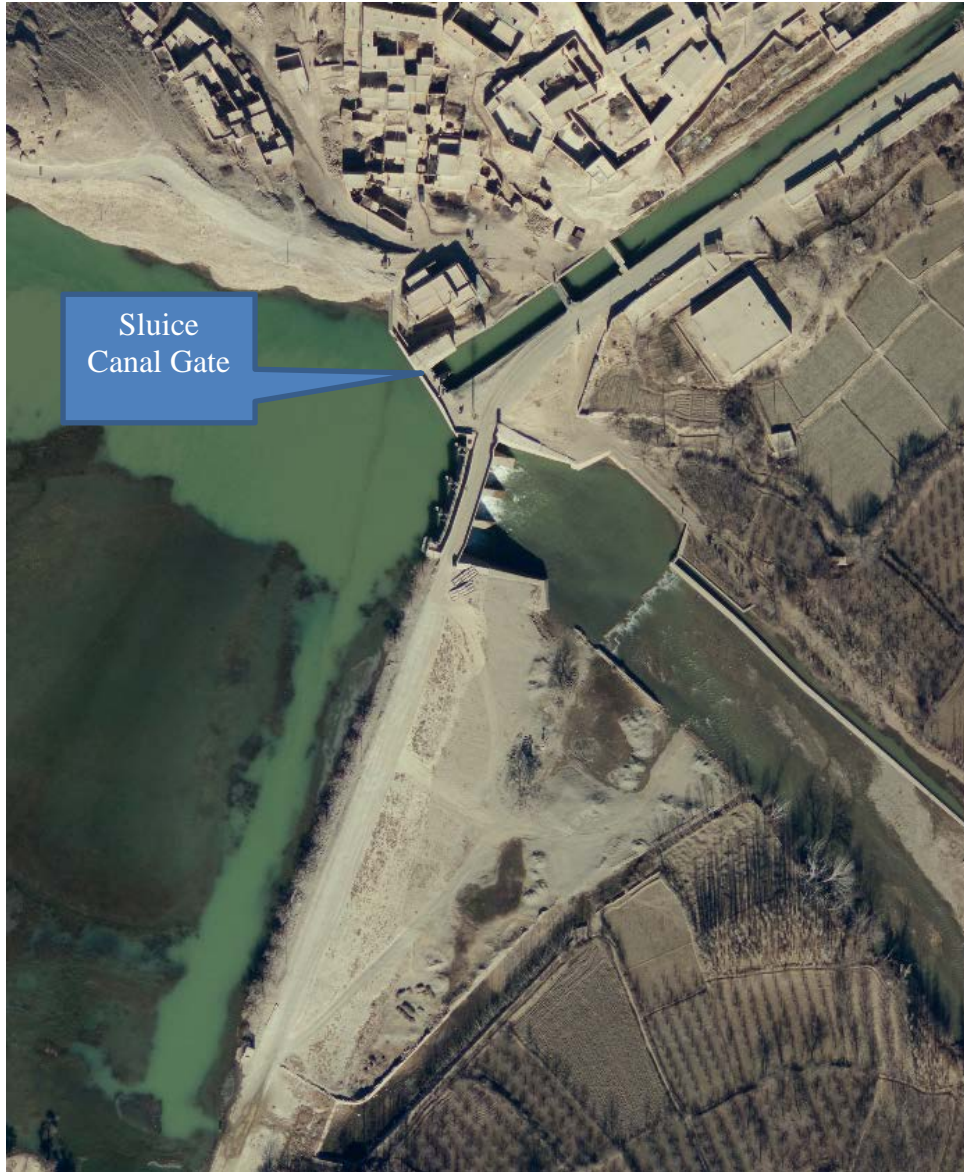
This dam (Figure 1) is the oldest dam in Afghanistan, built in 1938. Its purposes are to regulate flow of irrigation water in the Chak Valley and to provide hydro-electric power. Its designed capacity is 3.3 mW, but apparently only one of its three generators is functional now. It is 304 m long and 10 m high. The reservoir appears to have a high level of accumulated sediment, probably due to its age, since the contributing river is relatively stable. This dam was evaluated in the SEAFWRA (South East Afghanistan Water Resources Assessment) and concluded “Chak should be prioritized highly for repairs”. The contributing watershed is 441,500 ha with a mean annual discharge of 6.66 m<sup>3</sup>/s, and average annual runoff of 477 m<sup>3</sup>/ha. The area surrounding the dam is primarily eroded, medium-textured unconsolidated sediments with little bedrock .

Figure 1. The Chak E Dam in Wardak Province (Nov 2008)

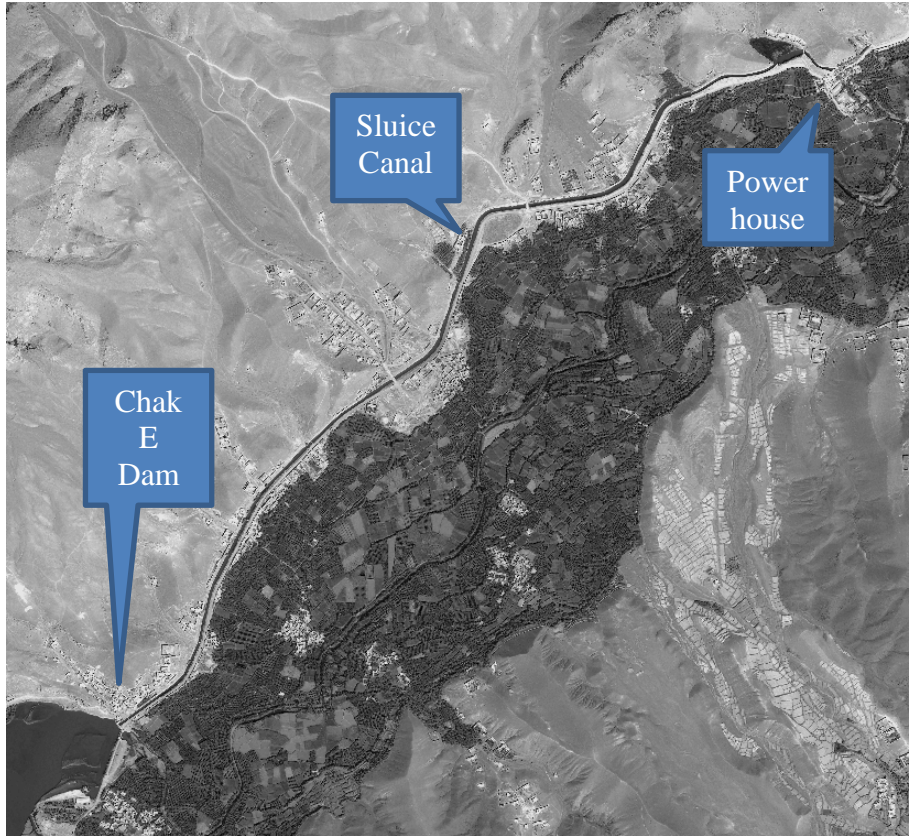
There is a gated canal originating in the northern corner of the dam (Figure 1). This canal leads to a powerhouse and irrigated fields about 4 km downstream (Figure 2).

Figure 2. The Sluice Canal at Chak Dam

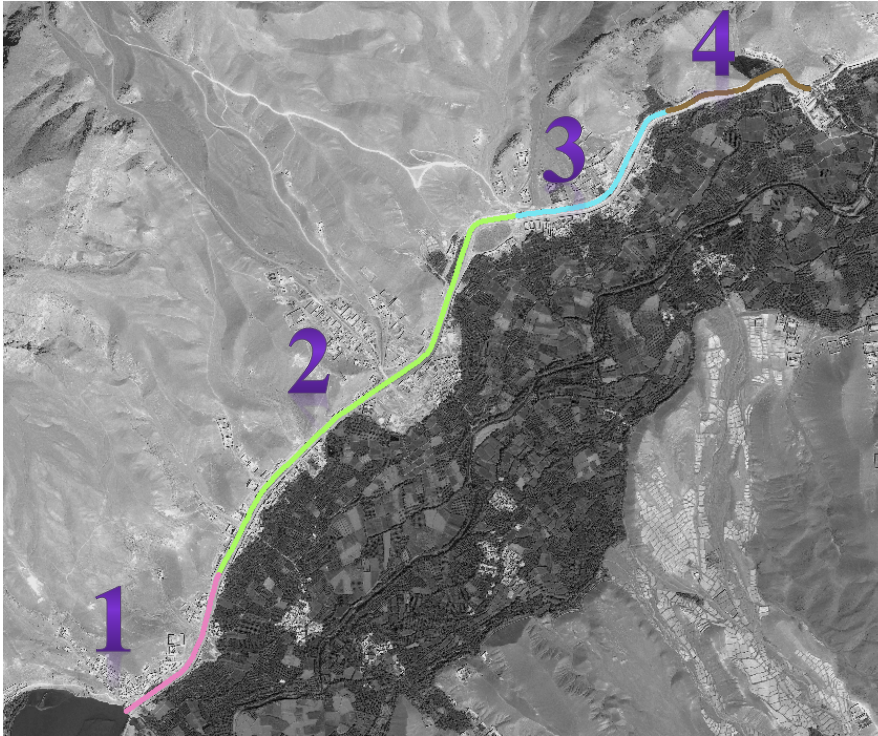
The sluice canal was segmented by characteristics (Figure 3). Segment One includes the concrete inlet, with relatively vertical walls, and an average bank width of 10.5 m. Segment Two has a wider, less maintained channel with sloping sides and an average width of 17.6 m. The adjoining road is slightly above the channel. Segment Three shows effects of flooding from

an alluvial fan north of its starting point, has more existing dredging, and the adjoining road is below the elevation of the channel with a protective berm. Its average width is 21m. Segment Four is outside of the BUCKEYE imagery footprint, so has less accurate measurements. It is similar to Section One in width and channel character.

Figure 3. Sluice Canal Channel Segments

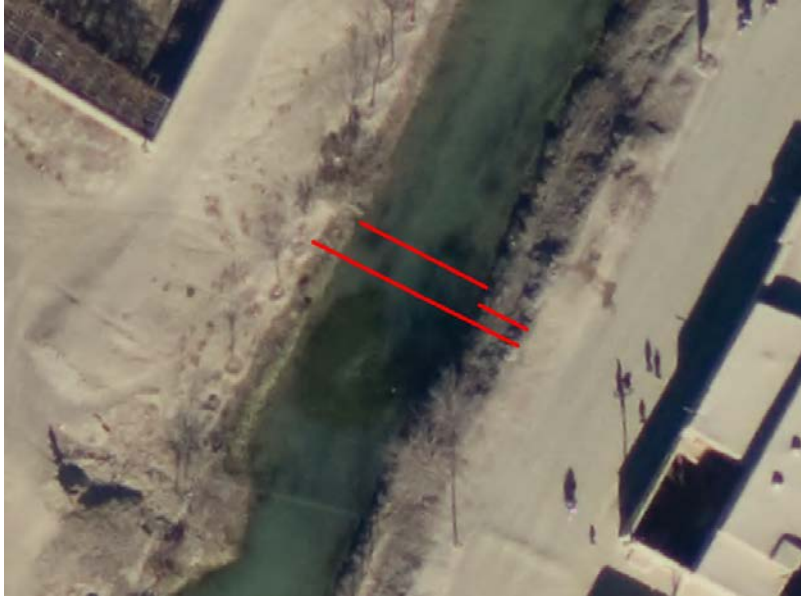
Existing sediment levels were estimated using a trapezoidal cross section with an estimated 4 m flat bottom. Channel width, sediment layer width, and exposed sideslope width were estimated from 1:200 scale imagery (Figures 4 and 5). Sediment elevation was estimated from the July 2010 elevation model (Figure 6), since the corresponding imagery (Figure 5) appears to show very shallow water depths at that time. Side slope length, depth, and side slope angles were generated for six representative cross sections (two for each channel Segment, POI's 38 – 43 from Table 2 below and on detail map) overlaid on a rectified digital elevation model, and cross sectional areas were calculated trigonometrically.

Figure 4. Representative Section of Sluice Channel: Nov 2010. Red lines are channel width, sediment width, and exposed sideslope width resp.

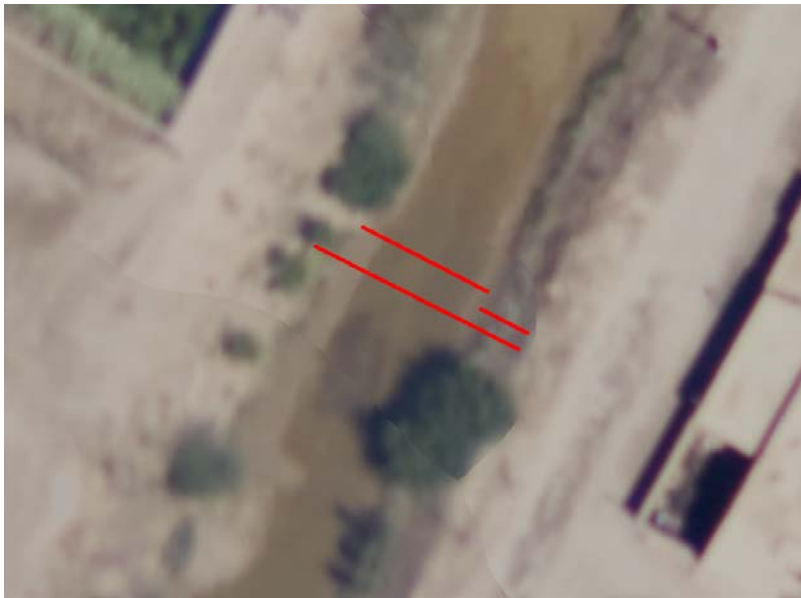
Figure 5. Representative Section of Sluice Channel: July 2010. Red lines are channel width, sediment width, and exposed sideslope width resp.

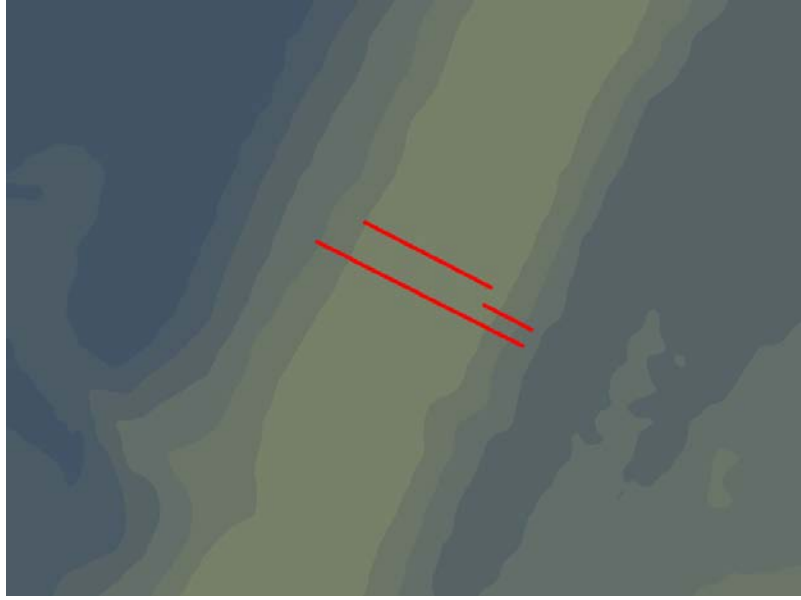
Figure 6. Representative Section of Sluice Channel: Elevations in July 2010. Red lines are channel width, sediment width, and exposed sideslope width resp.
